Evaluation Report 285

John Deere 1900 Seeding Tiller

ALBERTA
FARM
MACHINERY
RESEARCH
CENTRE

JOHN DEERE 1900 SEEDING TILLER

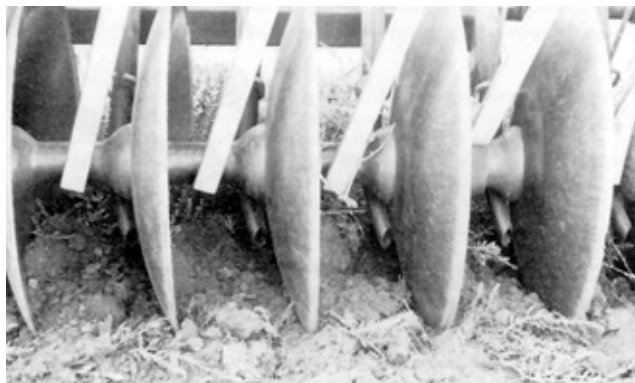
FIGURE 3. Seed Tube Position.

Seed Placement: Seed placement was good in most field conditions. The seed tubes were positioned behind the disk as shown in FIGURE 3 to place the seed at the bottom of the furrow. At 8 km/h (5 mph) most seeds were placed within 12 mm (0.5 in) of the average seed depth. Higher speeds caused some seed scattering. Seed placement was slightly better in summerfallow than in stubble fields. In very trashy fields, seeds were placed amidst the trash if the disks failed to cut through it. If the trash was cut by the disks, the seeds were placed near the furrow bottom, and covered by a loose mixture of soil and trash. Seed placement in rough undulating fields was variable. In the bottom of steep ravines or gullies, seed was placed on the soil surface as the disks were unable to follow sharp variations in ground contour. Characteristic of all disk harrows, soil was not compacted firmly about the seeds. It is important that packers be used after seeding, especially in dry, loose or trashy soils, to aid seed germination and plant growth.

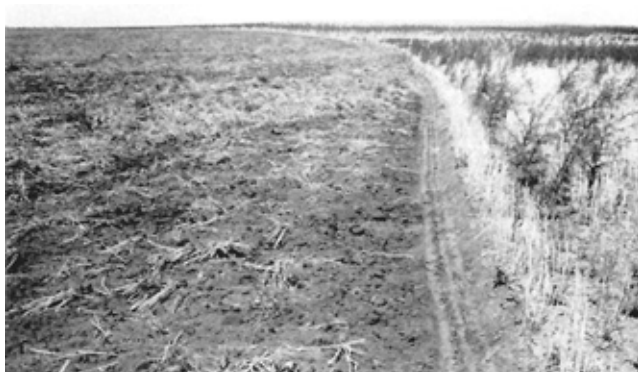
FIGURE 4. Soil Surface after Seeding into Stubble: (A) Heavy Trash Cover, (B) Light Trash Cover.

Ridging: The John Deere 1900 usually produced an even seedbed with a uniform soil surface (FIGURE 4) provided it was properly adjusted and the tractor driven at a steady speed and consistent distance from the furrow. Untilled strips between

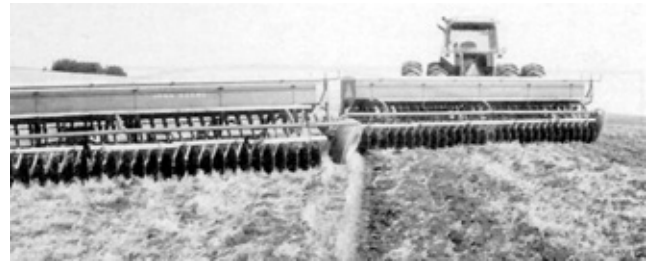
FIGURE 5. Centre Furrow Wheel Leaving the Furrow when Width of Cut Exceeds 9.2 m.

the front and rear units occurred on steep hillsides or when operating at a width of cut greater than 9.2 m (30 ft) (FIGURE 5). Slight furrow bottom ridging occurred on hillsides and gradual left turns as the width of cut increased. Furrow bottom ridging decreased with narrower widths of cut. A width of cut 10% less than the nominal width of cut is recommended for seeding to obtain a good weed kill and to provide a uniform furrow bottom for seed placement. At speeds above 9.6 km/h (6 mph), bouncing of the disk harrow produced an uneven seedbed. Slight soil surface ridging occurred when making gradual right turns. In dry soils, a smoother surface with fewer lumps was obtained at higher ground speeds.

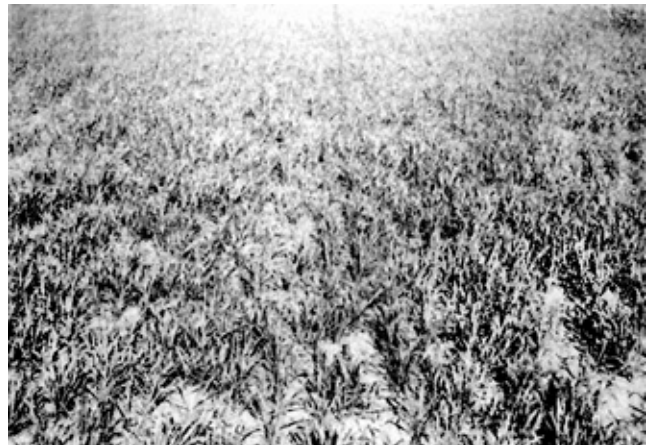
FIGURE 6. Neepawa Wheat 37 Days after Seeding into Summerfallow. Moisture Conditions Slightly Below Average.

Seed Emergence: Seed emergence was uniform (FIGURE 6) in all fields with sufficient moisture and nutrient reserves. Emergence was delayed in hard soils or heavy trash areas of dry stubble fields (FIGURE 7).

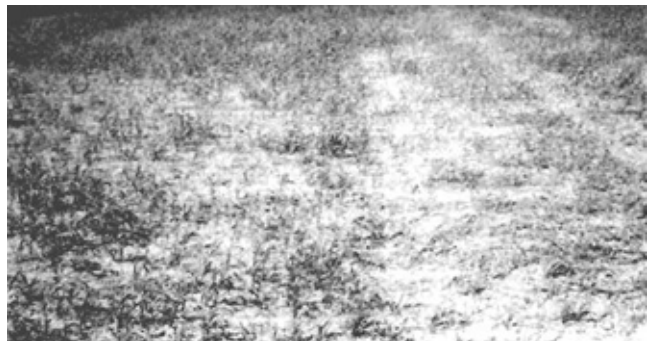
FIGURE 7. Patchy Emergence of Neepawa Wheat 42 Days after Seeding Directly into Hard Stubble with Rows of Heavy Trash. Moisture Conditions Below Average.

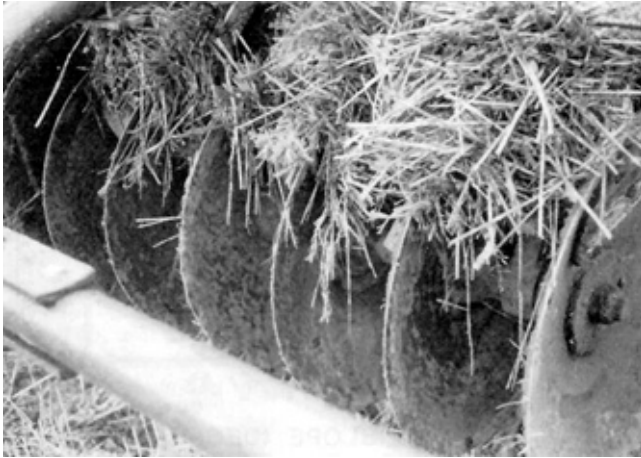
The rock deflectors reduced the buildup of trash, but did not prevent mud from clinging to the disks. Optional disk scrapers reduced the mud buildup in moist soils, but occasionally mud and straw collected between the scraper and the disk to cause plugging (FIGURE 13). As is common with most one-way disk harrows, plugging occurred more readily at reduced widths of cut and at increased working depths.

FIGURE 13. Trash and Mud Buildup Between the Scrapers and Disks.

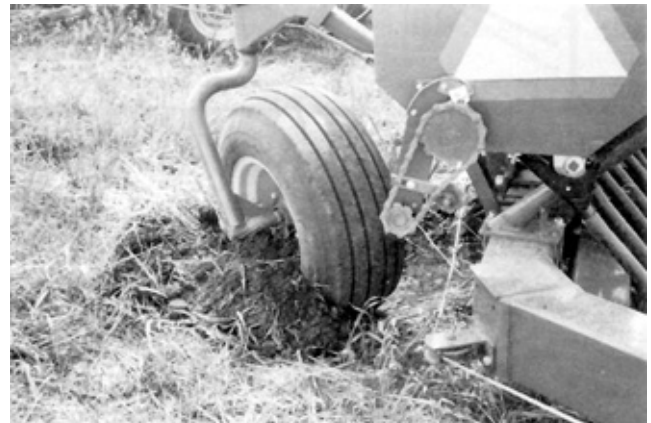
Turning: Left 90° turns were easily made. Sharp left turns greater than 90° caused excessive skidding of the rear land wheel if it was locked to prevent castoring (FIGURE 14). Skidding became more severe when the rear stabilizing coulter was used. Tilled corners were smooth and could easily be covered by two passes when finishing the field. Sharp right turns had to be made with caution due to interference between the trac-

FIGURE 14. Skidding of the Locked Rear Land Wheel when Making Left Turns Greater than 90°

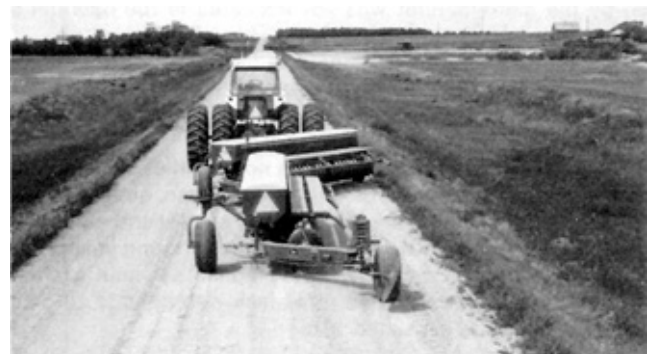
FIGURE 15. Full Transport Position.

Transporting: The John Deere 1900 could be safely transported at speeds up to 34 km/h (21 mph) when in full transport position, providing the seed and fertilizer boxes were empty. It could be put into or taken out of full transport position by one man in about 20 minutes. Wheel lead adjustments were not required when changing to or from transport position. A jack was needed for adjusting the hitch and for hitching to the tractor. It is recommended that the manufacturer supply a jack for the main hitch. A lock on the hydraulic cylinder prevented the disk gangs from being lowered while transporting. Damage could not occur when the hydraulics were activated with the lock engaged. Transport width was narrow enough to allow most vehicles to pass on secondary roads (FIGURE 15).

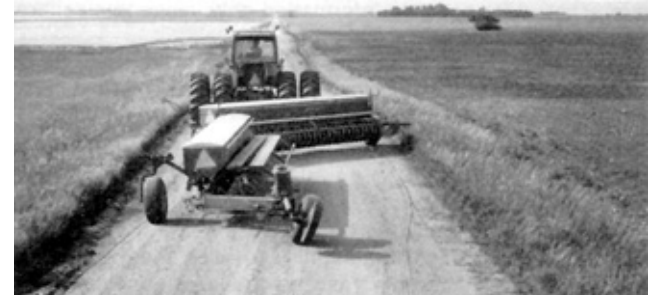
FIGURE 16. Semi-Transport Position.

The John Deere 1900 could be safely transported at speeds up to 21 km/h (13 mph) when in semi-transport position (FIGURE 16). Semi-transport width was only 760 mm (30 in) wider than full transport width making transport on secondary roads safe and easy. The John Deere 1900 could be placed in or taken out of semi-transport by one person in about 10 minutes. Right or left turns were easily made in semi-transport.

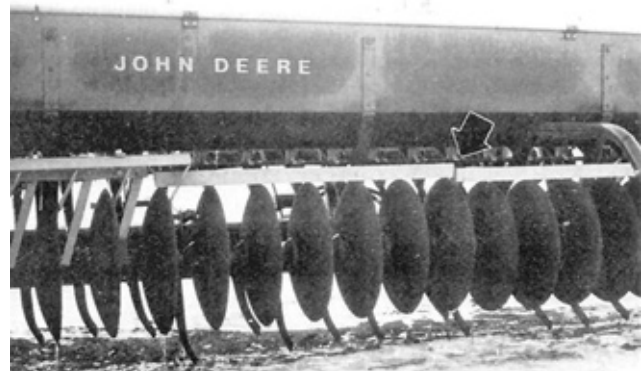
Disk Gangs: Four disk gang frames were slightly twisted when operating in stony fields (FIGURE 19). It is recommended that the manufacturer consider strengthening the disk gang frame to prevent twisting in stony fields.

FIGURE 19. Twisting of the Disk Gang Frame.

1. Supplying a jack for the main hitch.
2. Including in the operator's manual all pressure grease fittings and recommended servicing of the drive chains.
3. Modifying the disk gang frames to prevent twisting in stony fields.
